## Instructions for SPRKI04 repair kit for Oxy Turbo Regulators

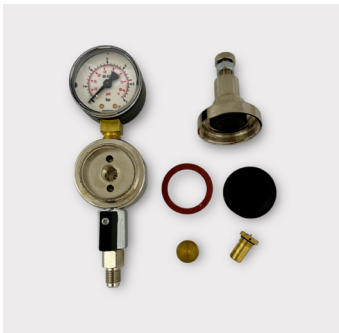
<p>4 Remove all parts</p>

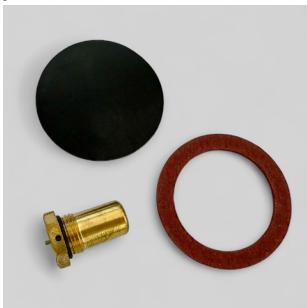
<p>5 Replace with the three parts in the repair kit:</p>

<p>6 Tighten seat nut firmly with socket by rotating clockwise and replace cover</p>
