# 8.2 Service procedures

### 8.2.1 Perlick beer tap 650SS

## 8.2.2 Perlick beer tap 630SS

# 8.2.3 Universal beer tap

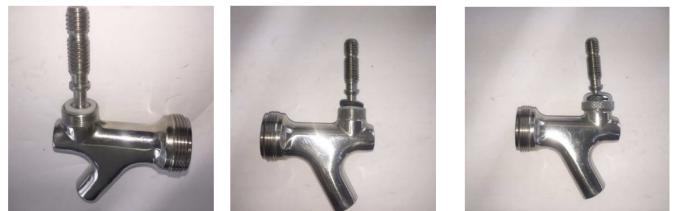
Re-assembly : Step 6: Push in piston into tap body.

Line up slotted hole as shown in picture

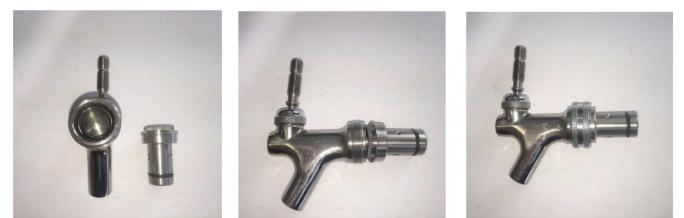
Step 7: Install white nylon friction with depression facing downwards. Install black friction gasket on top and screw bonnet nut clockwise. Tap should move fluidly with light pressure. Firm but free movement.
